CASE STUDY: GAS-LIQUID REACTOR OPTIMISATION

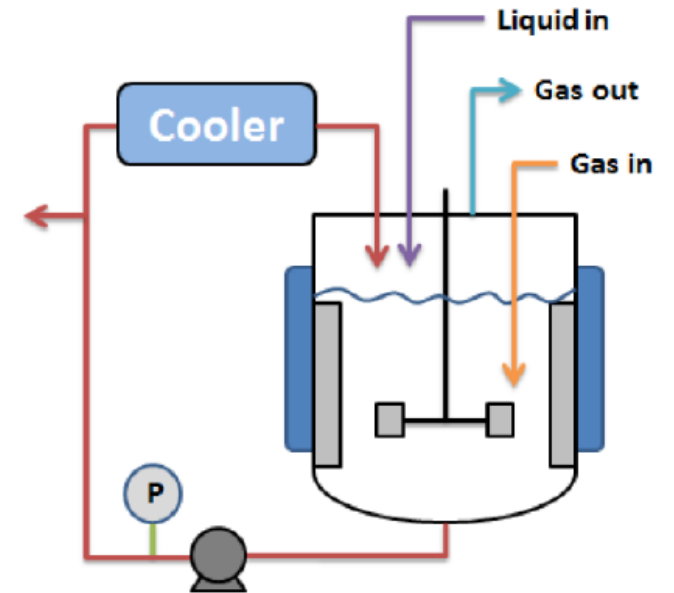
- Gas sparged by dip tube above the impeller
- Recirculation loop with heat exchanger for additional cooling

During commissioning, our client found that there were **pressure fluctuations** upstream of the pump in the recirculation loop **causing the pipe to shake**:

- Shaking was worse at lower fill levels
- **A solid by-product formed if the gas dispersion was poor**
 - The by-product of this was blocking heat exchanger

- Large scale fluctuations from asymmetric sparging were causing pressure fluctuations at the vessel base
 - This was accentuated by **poor piping design** between the base and the pump
- We identified that the heat exchanger **blocking was not caused by simple settling**

Having analysed the entire process incorporating the pipes, pumps and reactor, we presented our recommendations to our client, **working together to agree the best solutions** given their requirements. Our client took our advice, deciding against moving to a ring sparger and/or adding a new impeller and changed the impeller clearance along with the piping and pump design. These **changes resolved the pressure fluctuation issues, stopping the reactor shaking** and the associated by-product production.
