Goronyo Dam Spillway

WS ATKINS INTERNATIONAL, NIGERIA

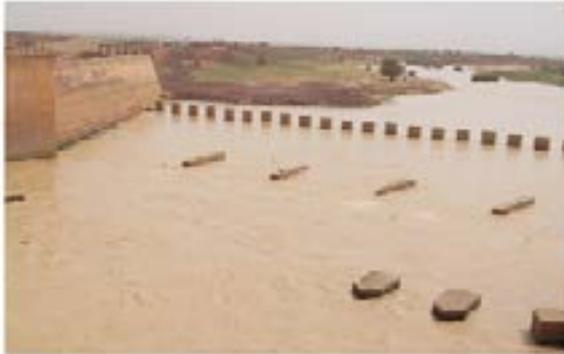
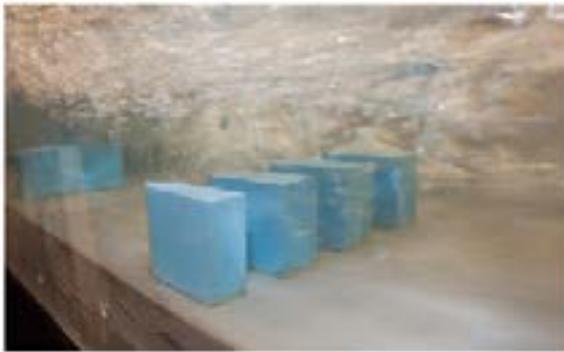
A model of the Goronyo Dam overflow was built and tested in the BHR Group laboratory to accurately represent conditions in the real spillway. Physical modelling allowed engineers and designers to quickly and accurately prove that the existing design performs adequately under all flow scenarios. In particular, the test programme was designed to:

- Obtain the free discharge curve for the ogee weir.
- Assess the impact on discharge of drowning of the ogee weir crest.
- Evaluate the impact on discharge of fully closing one spillway.
- Review stilling basin performance.

A full set of tests were conducted under steady state conditions operating at the design flowrates and downstream water levels specified by the client. The tests looked at the flow characteristics of the dam with either of the single spillways in operation or with both spillways open concurrently. These tests showed that the reservoir level was almost identical irrespective of which single spillway was in operation.

The reservoir level was also identical for free discharge and rising river levels downstream of the structure, with overtopping the embankment which could lead to failure. These results were sufficient to give the client confidence that the design of the spillway can cope with maximum flowrate conditions and rising river levels downstream of the structure, without failure.

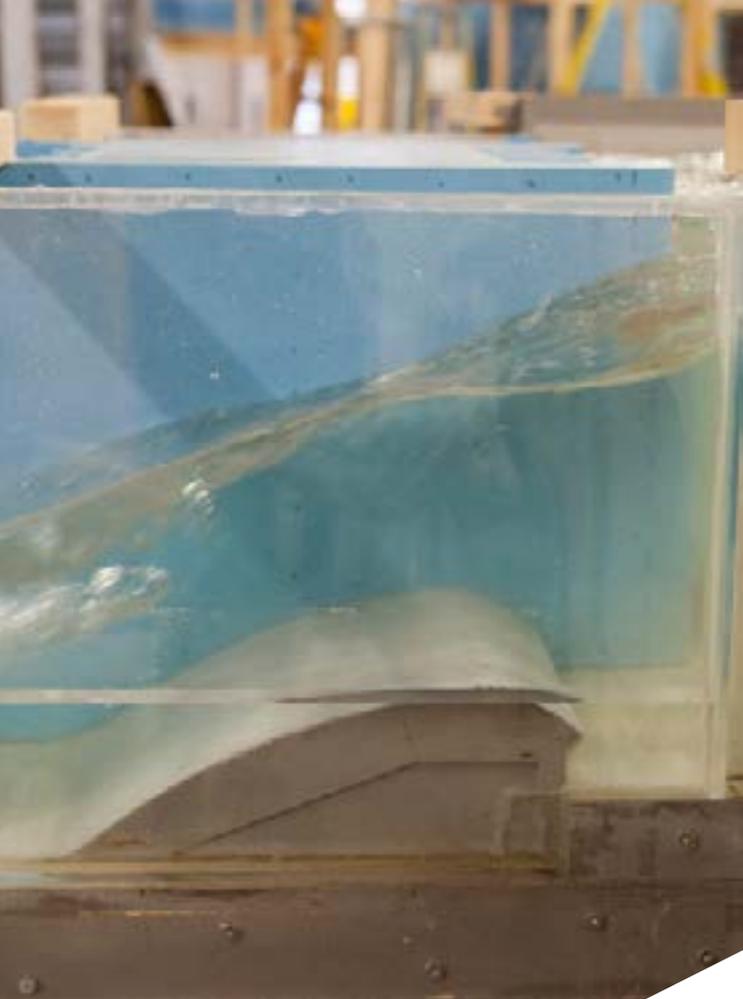
BHR modelled the Goronyo Dam overflow with the following critical features:

GATED SPILLWAYS WITH OGEE WEIRS

The gated spillways enable controlled release of water from the dam under flood flow conditions. Ogee crested weirs are commonly used in spillways as they give a high discharge efficiency.

ENERGY DISSIPATING STILLING BASIN

The energy dissipators in the stilling basin are critical for reducing the kinetic energy at the base of the spillway, so that flow into the downstream river is at a reduced rate and the downstream bed and banks are protected from erosion.

The model was constructed to a geometric scale of 1:35 and operated at flow rates to maintain equality of Froude Number. Key features of the model included:

- Two gated spillways with ogee weirs.
- Stilling basin with energy dissipation blocks.
- Wide river channel downstream of the stilling basin.
